Asbestos Re-inspection Report

Mitie FM - DFT Contract

WBRASI33
Teignmouth CRS
Ivy Lane
Teignmouth
Devon
TQ14 8BJ

Report Ref: A-04883 VI
Report Date: 01/09/2021
Issued On: 13/10/2021
Page: 1 of 10
Doc Control: TSPA(LR) 06.4P Rev C April 21

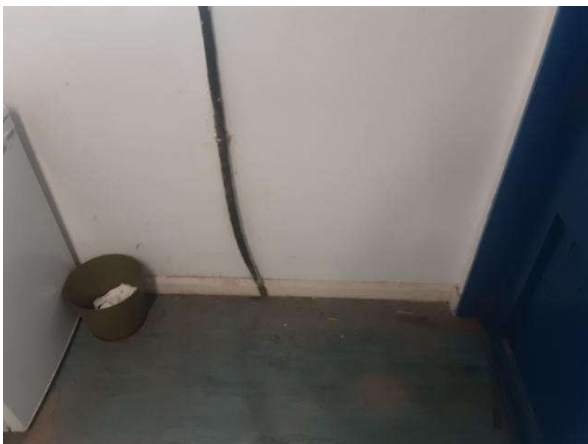
Sample Reference Number	
P 0011	
Sample Date	01/09/2021
Inspection Interval	12 months
Next Inspection	01/09/2022
Inspection Type	Re-Inspection
Surveyor 1	Ben Walters
Surveyor 2

Sample Location	
Building	Teignmouth CRS
Floor	Ground Floor
Sub Area	001 / Drying room / Kitchen
Component	Bitumen
Quantity	2 lin m
Lab Ref	
Accessibility	Medium
Type	Presumed

Material Assessment		
Product	I. Bituminous Product	
Condition	0. Good	
Surface	0. Composite materials containing asbestos: reinforced plastics, resins, vinyl tiles.	
Type	I. Chrysotile	
Score	2	Band - D

Notes
Reinspected 2021, No change to condition of material. Continue to manage.

Overall Score	
Material + Priority Assessment =	3
Recommended Action	
Manage

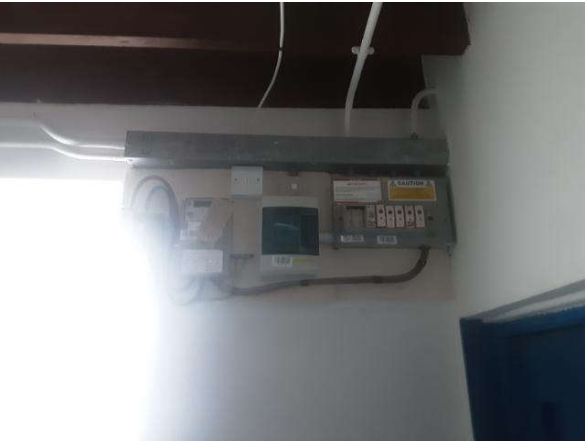
Sample Reference Number	
P 0007	
Sample Date	01/09/2021
Inspection Interval	12 months
Next Inspection	01/09/2022
Inspection Type	Re-Inspection
Surveyor 1	Ben Walters
Surveyor 2

Sample Location	
Building	Teignmouth CRS
Floor	Ground Floor
Sub Area	001 / Drying room / Kitchen
Component	Electrics
Quantity	8 no
Lab Ref	
Accessibility	Difficult
Type	Presumed

Material Assessment		
Product	2. Textile Rope / String	
Condition	0. Good	
Surface	1. Enclosed sprays and lagging, AIB (with exposed face painted or encapsulated) asbestos cement sheets etc.	
Type	1. Chrysotile	
Score	4	Band - D
Very Low Risk

Notes
Reinspected 2021, No access into live electrics however they appear modern. Continue to manage.

Overall Score	
Material + Priority Assessment =	5
Recommended Action	
Manage

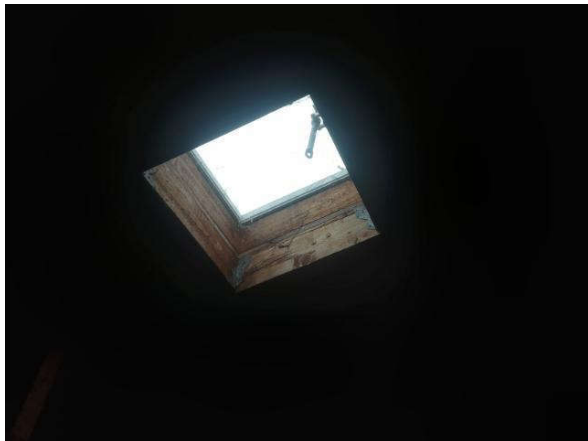
Sample Reference Number	
P 0009	
Sample Date	01/09/2021
Inspection Interval	12 months
Next Inspection	01/09/2022
Inspection Type	Re-Inspection
Surveyor 1	Ben Walters
Surveyor 2

Sample Location	
Building	Teignmouth CRS
Floor	Ground Floor
Sub Area	002 / Garage
Component	Rope Seal
Quantity	Small amounts no
Lab Ref	
Accessibility	Difficult
Type	Presumed

Material Assessment		
Product	2. Textile Rope / String	
Condition	0. Good	
Surface	1. Enclosed sprays and lagging, AIB (with exposed face painted or encapsulated) asbestos cement sheets etc.	
Type	1. Chrysotile	
Score	4	Band - D
Very Low Risk

Notes
Reinspected 2021, No change to condition of material. Continue to manage.

Overall Score	
Material + Priority Assessment =	5
Recommended Action	
Manage

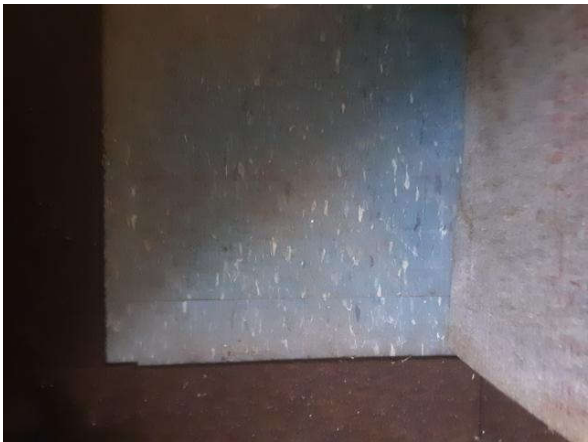
Sample Reference Number	
PS 0003	
Sample Date	01/09/2021
Inspection Interval	12 months
Next Inspection	01/09/2022
Inspection Type	Re-Inspection
Surveyor 1	Ben Walters
Surveyor 2

Sample Location	
Building	Teignmouth CRS
Floor	Ground Floor
Sub Area	003 / Office
Component	Floor tiles and bitumen adhesive
Quantity	20 m ²
Lab Ref	
Accessibility	Medium
Type	Previously Sampled

Material Assessment		
Product	1. Vinyl Tiles	
Condition	0. Good	
Surface	0. Composite materials containing asbestos: reinforced plastics, resins, vinyl tiles.	
Type	1. Chrysotile	
Score	2	Band - D
Very Low Risk

Notes
Reinspected 2021, No change to condition of material. Continue to manage.

Overall Score	
Material + Priority Assessment =	4
Recommended Action	
Manage
